June 28, 2019

Re: Wetland Assessment
401 Volvo Parkway, Chesapeake, Virginia
City of Chesapeake Tax Parcel #0280-000-000790 & 0373-010-000390

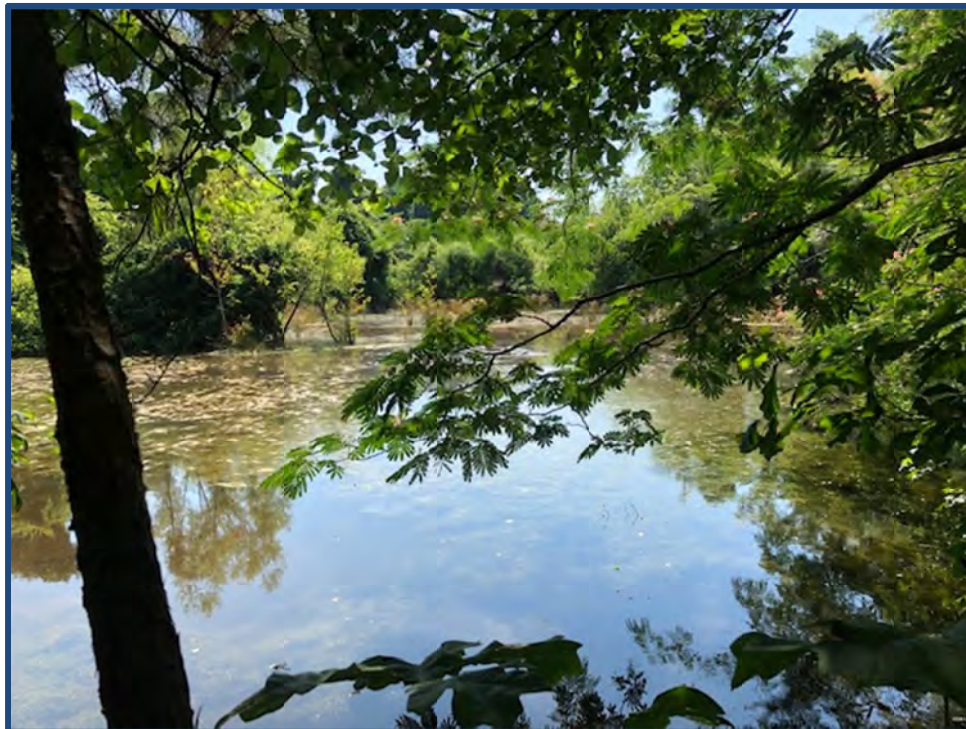
Photograph 1: Representative view of the potentially jurisdictional pond

Three ponds were observed during the site investigation. The northernmost and easternmost ponds appear to be stormwater management features and would most likely be considered non-jurisdictional by the U.S. Army Corps of Engineers. These two ponds are approximately 7.47 acres. The pond near the center of the study area (0.97 acre) does not appear to be maintained and would most likely be considered a jurisdictional feature by the Army Corps.

We recommend having a wetland delineation completed on the site and the U.S. Army Corps of Engineers confirming that delineation. If you have any questions, or desire any additional information, please do not hesitate to call me at 757-436-5900.

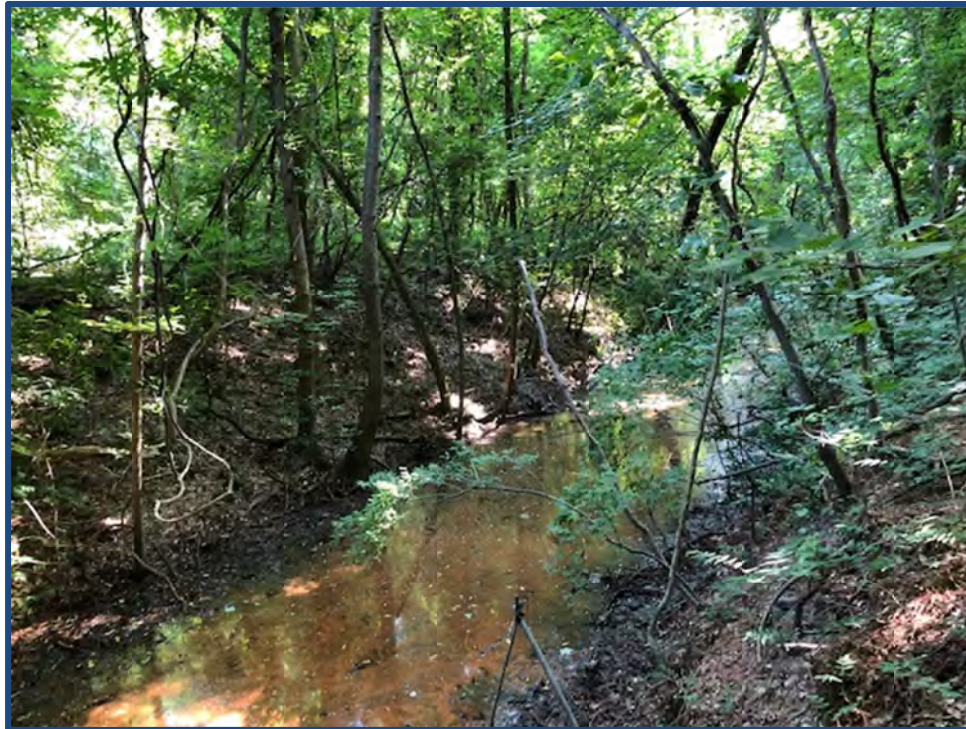
Photograph 2: Representative view of a potentially jurisdictional ditch

A grid-like system of ditches was observed throughout the study area. Based on the new Waters Rule, the majority of the ditches should be considered non-jurisdictional because they do not appear to be relocated tributaries and do not appear to have perennial flow. Approximately 3,006.65 linear feet of the ditches observed on site will most likely be considered to be jurisdictional features because they appear to have perennial flow.

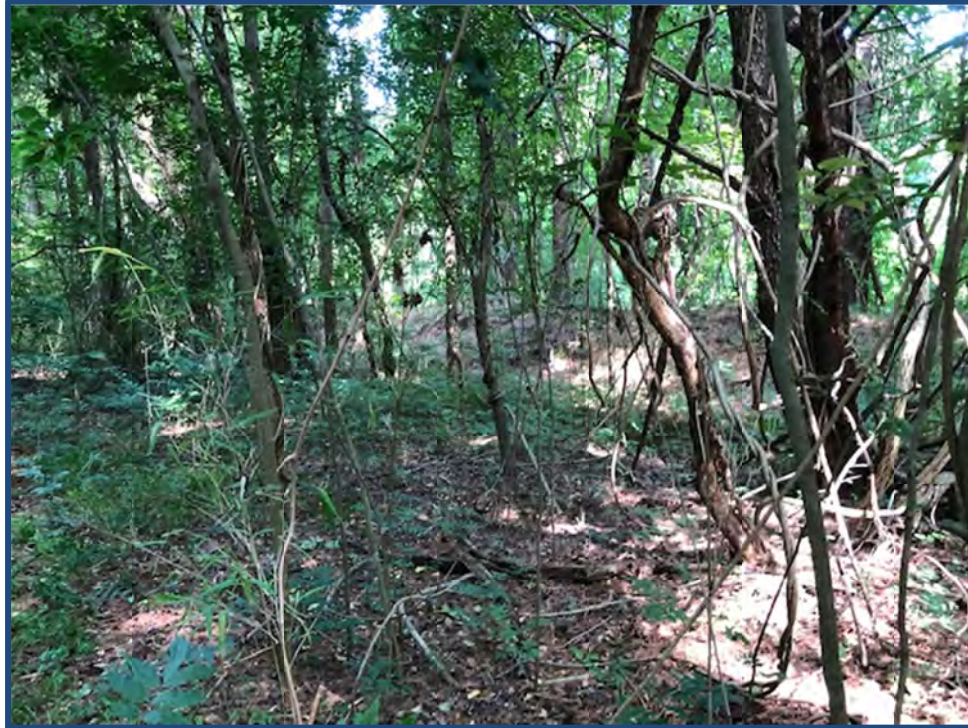
Photograph 3: Representative view of a forested upland area

The remainder of the study area, approximately 134.44 acres, consisted of potential uplands. Overall, the site is well drained due to the ditch system. The forested areas contained a variety of ornamental plant species in addition to more native species. Some of the upland plant species observed included crab apple (*Malus coronaria*), Chinese wisteria (*Wisteria sinensis*), ebony spleenwort (*Asplenium platyneuron*), bracken fern (*Pteridium aquilinum*), witch hazel (*Hamamelis virginiana*), southern red oak (*Quercus falcata*), black cherry (*Prunus serotina*), and Virginia creeper (*Parthenocissus quinquefolia*). The soil was generally grey with mottles and met the depleted matrix hydric soil indicator throughout the majority of the uplands. No hydrology indicators were observed throughout the uplands.
